Manhole Inspection Summary

Manhole # S31E__017MH

Insp Date: **8/11/08 9:46 AM**

Location Address: **130 n paca st**

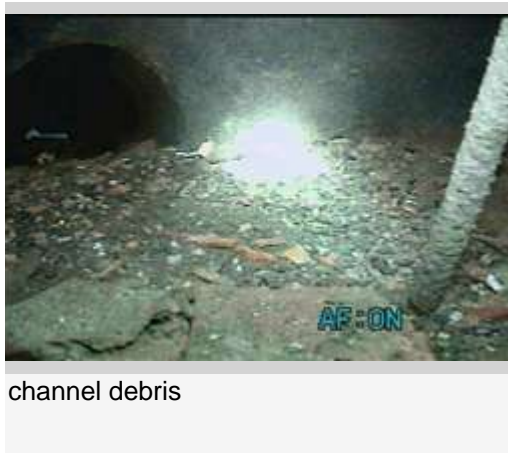
Defect 3

Condition: ☐ Sound ☐ Cracked ☐ Root Intrusion ☐ Deteriorated ☐ Leaks ☒ **Debris**

channel debris

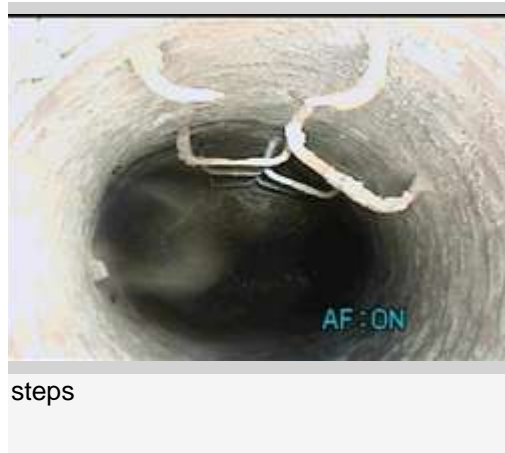
Defect 2

Count: **8** Missing: **1** ☒ **Corroded**

steps

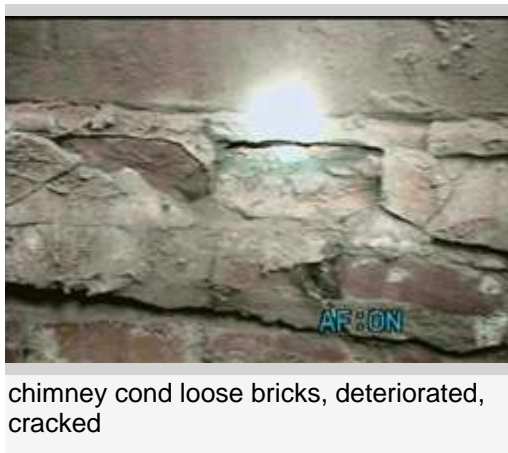
Defect 1

Condition: ☐ Sound ☒ **Cracked** ☐ Root Intrusion ☒ **Loose Brick** ☒ **Deteriorated**

chimney cond loose bricks, deteriorated, cracked
